Concrete Protection System

4151

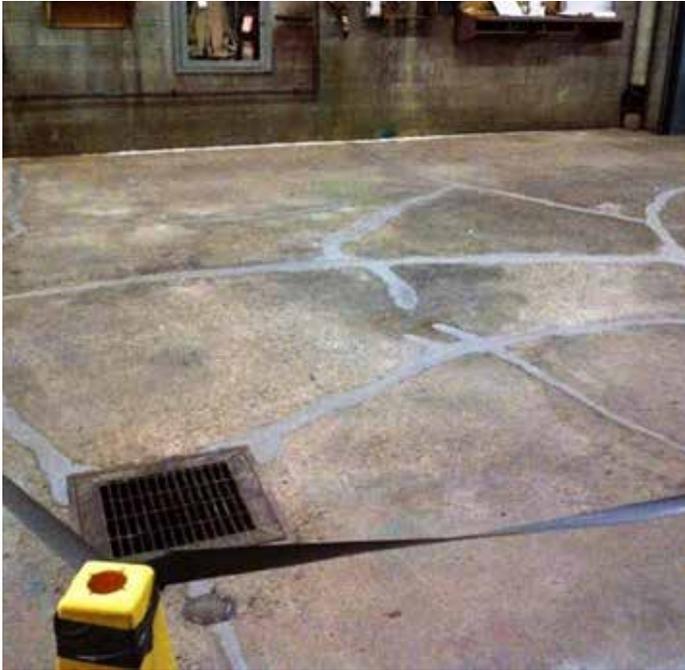
Crack repaired with Belzona 4151 and 4111 system

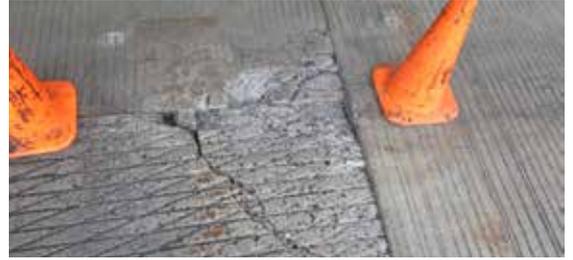
A concrete panel had cracked causing problems on the road

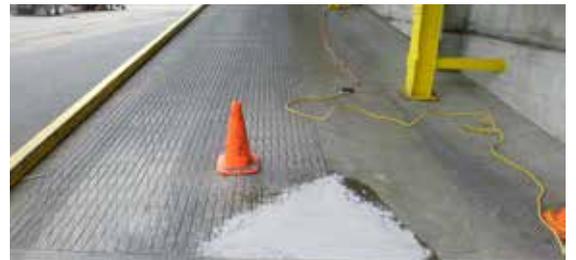
The Belzona 4151 + 4111 system was used to rebuild and smooth the cracked area

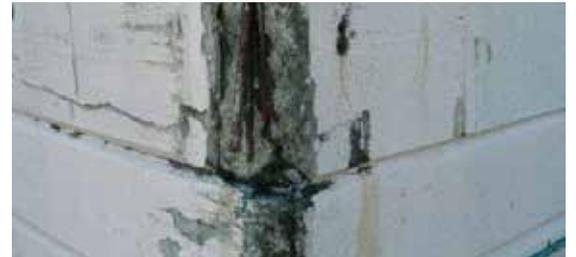
A wall corner was severely damaged

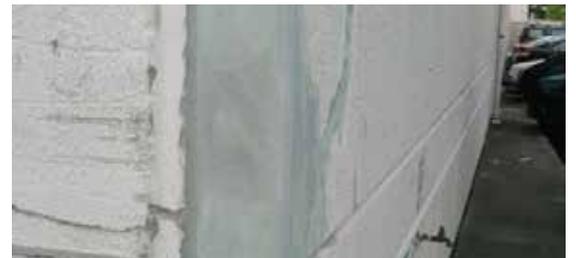
Belzona 4151 was injected before cracks were filled with Belzona 4111
