# Belzona SuperWrap II

ISO/ASME compliant composite repair solution for restoring strength to pipes and tank walls.

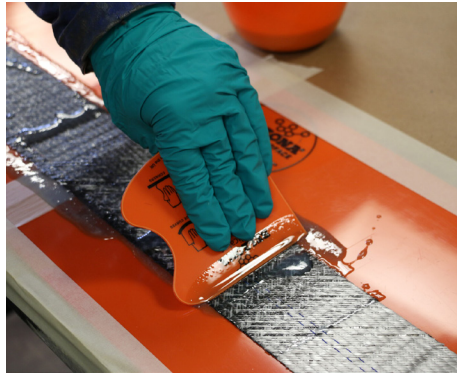
## Belzona 1981

Low-temperature resin for application temperatures of 5°C (41°F) - 20°C (68°F) and operating temperatures up to 60°C (140°F).

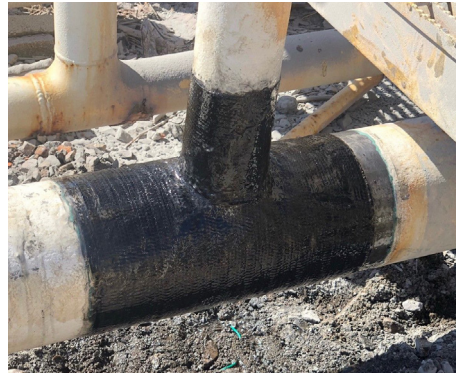
## Belzona 1982

Extended working life resin for application temperatures of 20°C (68°F) - 40°C (104°F) and operating temperatures up to 80°C (176°F).

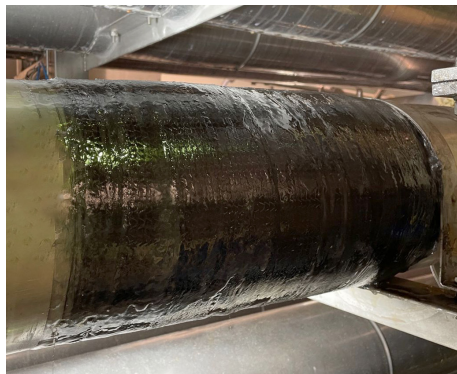
## Belzona 1983

High-temperature resin for application temperatures of 5°C (41°F) - 40°C (104°F) and operating temperatures up to 150°C (302°F).

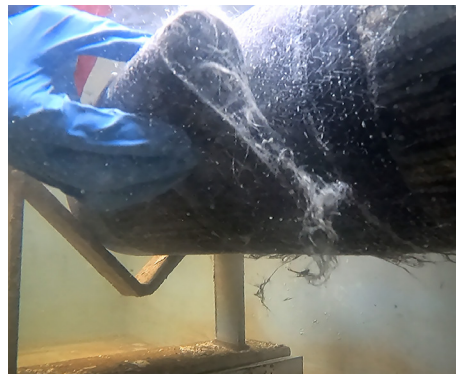
## Belzona 1984

Surface tolerant resin for service temperatures up to 50 °C (122 °F) and suitable for minimum application temperature of 5 °C (41 °F).

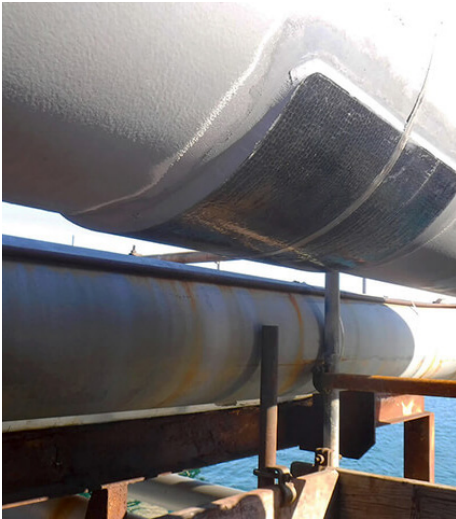
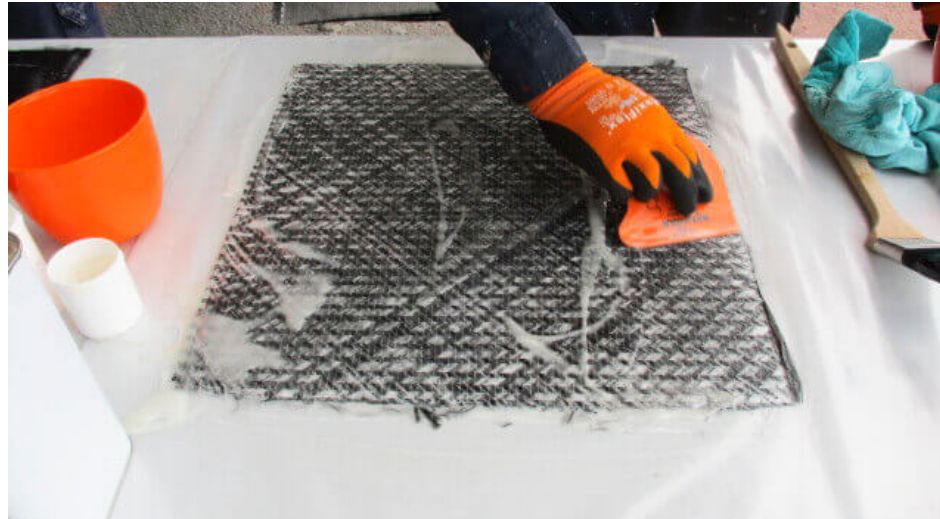
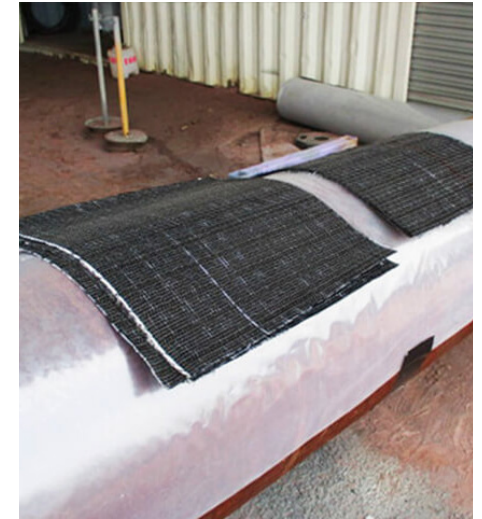
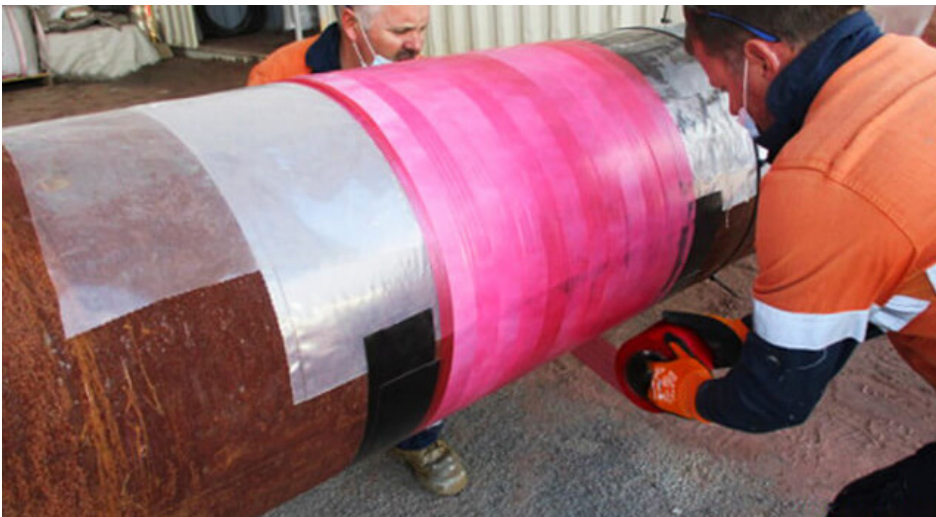
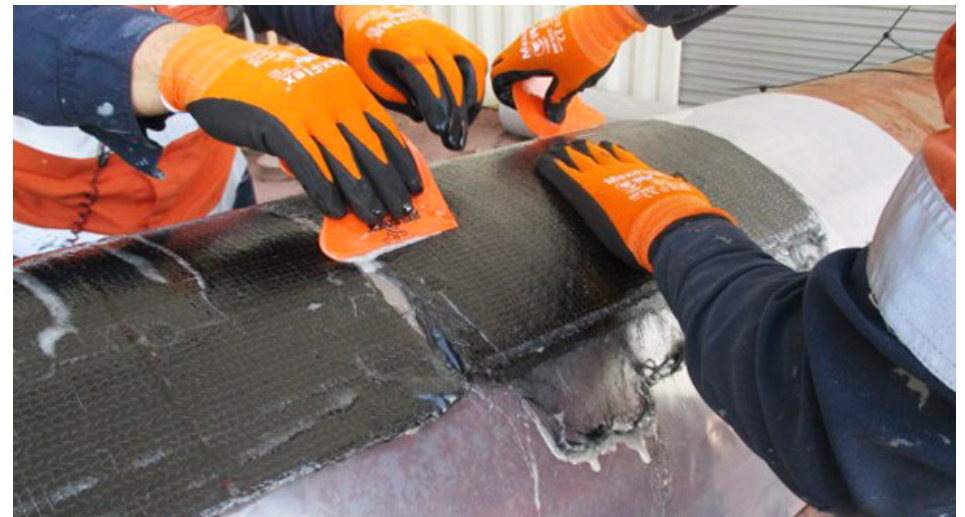
# Belzona Composite Pad

The Belzona Composite Pad is specially designed to facilitate the fast and simple in-situ repair of through-wall and thin-wall defects on pipes and tank walls. It is a reliable alternative to welding and mitigates the need to replace defective metallic substrates, whilst providing superior strength, chemical and corrosion resistance.
